**Flood Control Project Maintenance
Levee Inspections**

Fall 2018 Levee Maintenance Deficiency Summary Report

Reclamation District No. 0150 Merrit Island

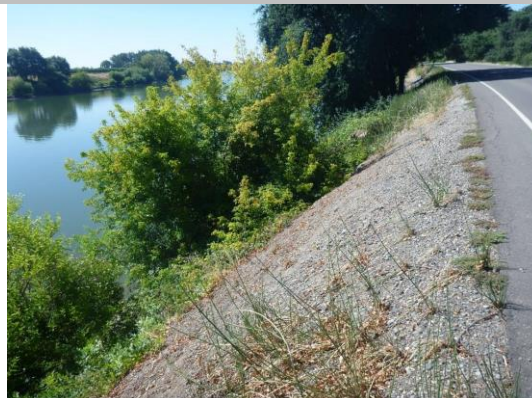
Photo 2 of 4 : LEVAL_FA_2018_288_2155.jpg

Comment Code					
Inspector Comment					
Levee Evaluation Comments					
Description:The flood damage consists of a waterside erosion approximately 447 feet long on the west (right) bank of the Sacramento River. See attached pages for photos.					
Site ID No:288					
Site Designation:LMA-114					
Repair Type: Erosion					
Rating:Area of Concern					
Field Date:7/17/2017					
Notes: Crown is a paved road. Much of site was not accessible because of thorny veg. Scarps were only about 1 ft deep where it was accessible so rated it a lower priority. Irrigation pipe within the site. A boat view would be helpful here. Fall 2018 DWR Inspector: Erosion along bank not visible from levee crown.

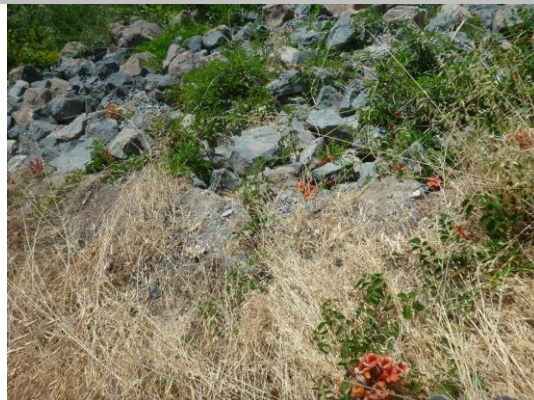
Photo 4 of 4 : LEVAL_FA_2018_288_2157.jpg

Comment Code					
Inspector Comment					
Levee Evaluation Comments					
Description:The flood damage consists of a waterside erosion approximately 447 feet long on the west (right) bank of the Sacramento River. See attached pages for photos.					
Site ID No:288					
Site Designation:LMA-114					
Repair Type: Erosion					
Rating:Area of Concern					
Field Date:7/17/2017					
Notes: Crown is a paved road. Much of site was not accessible because of thorny veg. Scarps were only about 1 ft deep where it was accessible so rated it a lower priority. Irrigation pipe within the site. A boat view would be helpful here. Fall 2018 DWR Inspector: Erosion along bank not visible from levee crown.

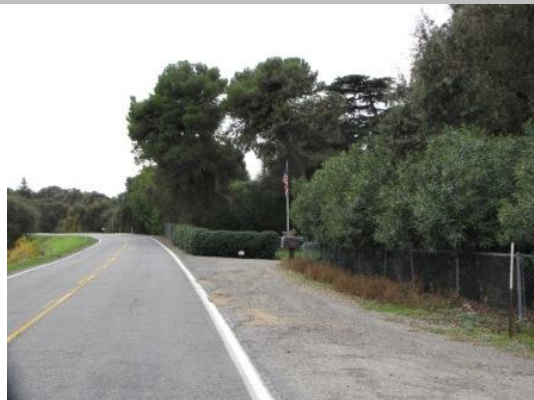
Photo 1 of 1 : FA_2018_RD0150_16_75_20180910_00048.jpg

LM Start	5.05	Rating **	U	Issue No.	75
LM End	5.14	Issue Type +	En	Location *	LS
Category	Earthen Levee			GPS Latitude/Longitude	
				Start	End
Item	Vegetation			38.378543 °	38.379839 °
				-121.525362 °	-121.524968 °
DWR ID	DWR_RD0150_02_s_2012_75				
Comment Code					
V6 : Landscaping					
Inspector Comment

View of landscaping along the landward shoulder and slope looking downstream.

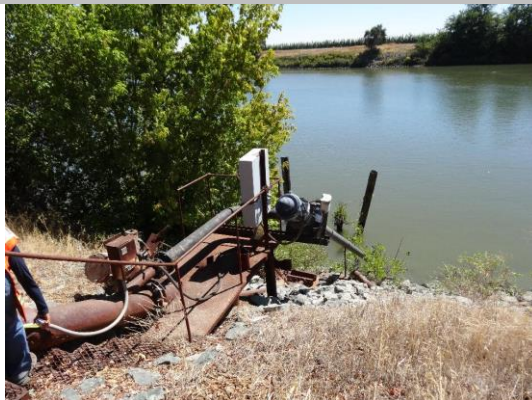
Photo 1 of 3 : UCIP_FA_2018_20740_34941.jpg

Comment Code						
Inspector Comment						
FS_ID:20740						
DS_ID:22410						
EP_NO: N/A						
Repair Type: Non-Urgent						
Crossing Status: Found						
UCIP Comments: - 2" electric conduit and gate valve on WS.-						
abandoned old pump not removed from WS- working during field						
survey						
FIELD_STRUCT_DESC: 12-inch steel irrigation discharge pipe and a 2-						
inch electrical conduit through the levee, invert elevation 3 feet below						
the crown. Service pole and standpipe at the landside (LS) toe. (C.						
Sakai). [Additional Reference(s): DWR Levee Log, 2005. USACE						
Sacramento O&M Manual 112, March 1957, (RM 39.32)].						
FS Date: 8/30/2013

WS view: pipe, walkway, slant pump & pump platform on stream bank.

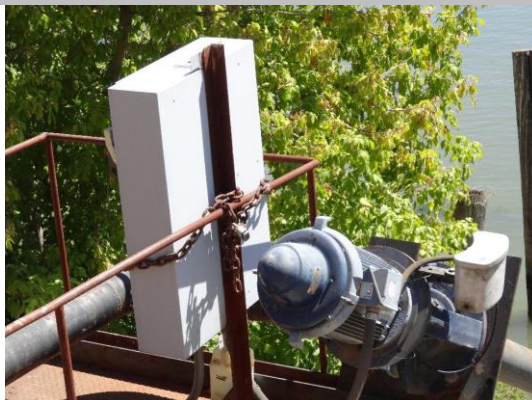
Photo 2 of 3 : UCIP_FA_2018_20740_34940.jpg

WS view: pipe, slant pump & pump platform on stream bank.

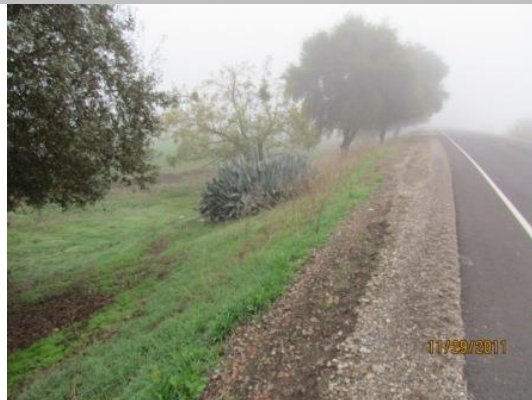
Photo 1 of 1 : FA_2018_RD0150_16_27_20180910_00012.jpg

LM Start	6.30	Rating **	M	Issue No.	27
LM End	6.30	Issue Type +	En	Location *	LS
Category	Earthen Levee			GPS Latitude/Longitude	
				Start	End
Item	Vegetation			38.393655 °	38.393655 °
				-121.514654 °	-121.514654 °
DWR ID	DWR_RD0150_02_s_2012_27				
Comment Code					
V6 : Landscaping					
Inspector Comment					
Century plant on the landward slope.

Century plant was found on the landside of the levee looking upstream.
Fall 2011

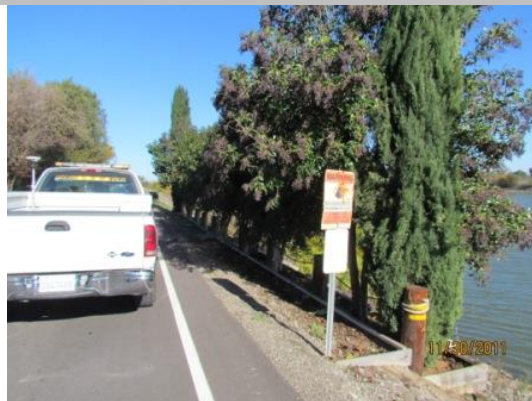
Photo 1 of 1 : FA_2018_RD0150_16_34_20180910_00017.jpg

LM Start	6.42	Rating **	M	Issue No.	34
LM End	6.42	Issue Type +	En	Location *	WS
Category	Earthen Levee			GPS Latitude/Longitude	
				Start	End
Item	Vegetation			38.395340 °	38.395340 °
				-121.514528 °	-121.514528 °
DWR ID	DWR_RD0150_02_s_2012_34				
Comment Code					
V6 : Landscaping					
Inspector Comment

Landscaping was found on the waterside of the levee looking upstream.
Fall 2011

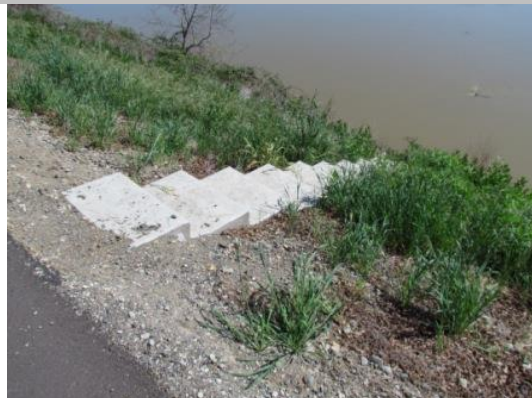
Photo 1 of 1 : FA_2018_RD0150_16_42_20180910_00018.jpg

LM Start	6.48	Rating **	M	Issue No.	42
LM End	6.48	Issue Type +	En	Location *	WS
Category	Earthen Levee			GPS Latitude/Longitude	
				Start	End
Item	Encroachments			38.396235 °	38.396235 °
				-121.514547 °	-121.514547 °
DWR ID	DWR_RD0150_02_s_2012_42				
Comment Code					
ST : Stairway					
Inspector Comment					
Unpermitted stairway.

A stairway was found on the waterside slope of the levee looking upstream.

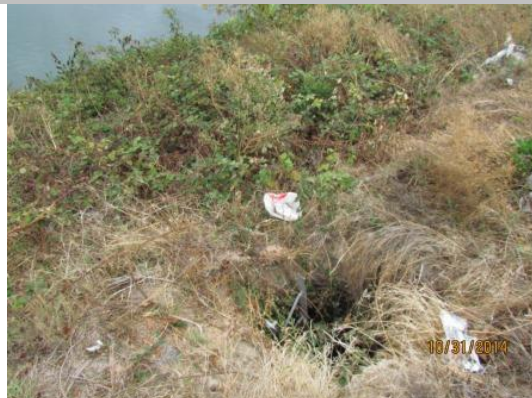
Photo 1 of 1 : FA_2018_RD0150_16_55_20180910_00037.jpg

LM Start	6.50	Rating **	U	Issue No.	55
LM End	6.50	Issue Type +	En	Location *	WS
Category	Earthen Levee			GPS Latitude/Longitude	
				Start	End
Item	Encroachments			38.396518 °	38.396518 °
				-121.514530 °	-121.514530 °
DWR ID	DWR_RD0150_02_f_2014_55				
Comment Code					
PI : Pipe					
Inspector Comment					
The pipe gate needs to be covered on the waterside toe of the levee.

An open pipe valve was found without a cover on the waterside toe of the levee. Fall 2014

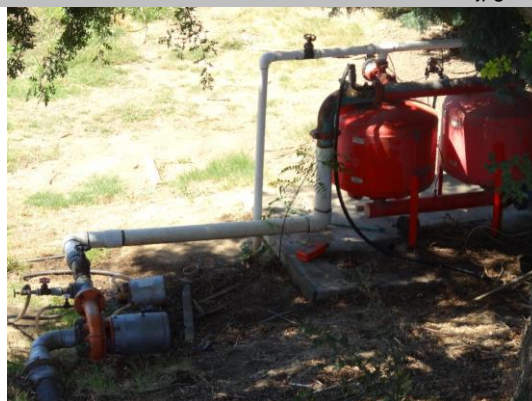
Photo 2 of 2 : UCIP_FA_2018_41720_34080.jpg

LM Start	6.57	Rating **	M	Issue No.	1006 (cont)	
LM End	6.57	Issue Type +	En	Location *		
Category	Supplemental			GPS Latitude/Longitude		
				Start		End
Item	DWR UCIP Field Study			38.397451 °		38.397451 °
				-121.514601 °		-121.514601 °
DWR ID	22425					
Comment Code						
Inspector Comment						
FS_ID:41720 DS_ID:22425 EP_NO: N/A Repair Type: Non-Urgent Crossing Status: Found UCIP Comments: Need to clear dense vegetation on WS.- water filtration plant on LS levee toe.- Slide gate on CMP riser on WS. FIELD_STRUCT_DESC: 8-inch irrigation discharge pipe of an unknown material through the levee, 12 feet below the crown. Gate valve in a corrugated metal pipe (CMP) riser on the waterside (WS) slope. Pump at the landside (LS) toe. (Joe Gomez). [Additional Reference(s): DWR Levee Log, 2005]. FS Date: 8/30/2013

LS view: concrete vault, pipe, and pump in water filtration plant.

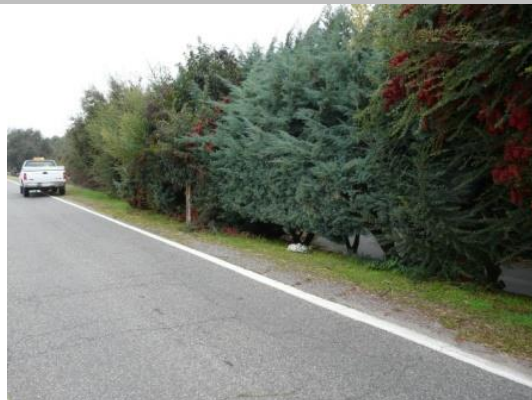
Photo 1 of 1 : FA_2018_RD0150_16_64_20180910_00044.jpg

LM Start	6.57	Rating **	U	Issue No.	64
LM End	6.61	Issue Type +	En	Location *	LS
Category	Earthen Levee			GPS Latitude/Longitude	
				Start	End
Item	Vegetation			38.397523 °	38.398000 °
				-121.514658 °	-121.514731 °
DWR ID	DWR_RD0150_02_s_2012_64				
Comment Code					
V6 : Landscaping					
Inspector Comment

Dense landscaping providing a screen for a residence on landside of levee.

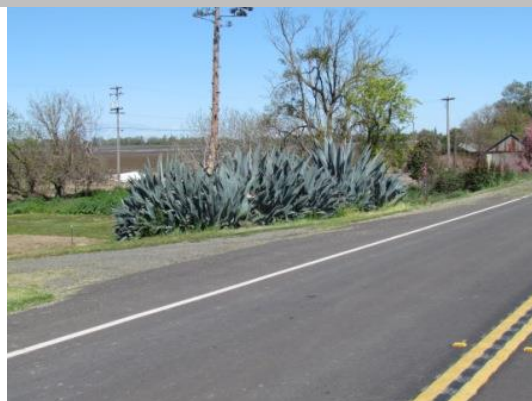
Photo 1 of 1 : FA_2018_RD0150_16_43_20180910_00019.jpg

LM Start	6.65	Rating **	M	Issue No.	43
LM End	6.68	Issue Type +	En	Location *	LS
Category	Earthen Levee			GPS Latitude/Longitude	
				Start	End
Item	Vegetation			38.398600 °	38.399042 °
				-121.514793 °	-121.514841 °
DWR ID	DWR_RD0150_02_s_2012_43				
Comment Code					
V6 : Landscaping					
Inspector Comment					
Landscaping and century plant on landside of the levee.

Century plants were found on the landside of the levee looking upstream.

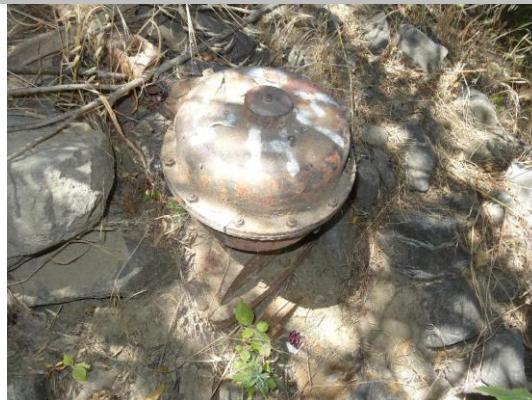
Photo 2 of 3 : UCIP_FA_2018_41646_34101.jpg

Comment Code					
Inspector Comment					
FS_ID:41646					
DS_ID:22426					
EP_NO: N/A					
Repair Type: Non-Urgent					
Crossing Status: Found					
UCIP Comments: - abandoned very old gate valve also found on WS.					
Rest of pipe should be evaluated due to its age.					
FIELD_STRUCT_DESC: 9-inch steel irrigation discharge pipe through the levee, invert elevation 9.7 feet below the crown. Gate valve and pump house on the landside (LS). (Retention of an irrigation pumping plant with a centrifugal pump on the LS levee slope with a 9-inch pipe through the levee authorized under Automatic Board Order (ABO) issued as Permit No. 8551, 1973 - Albert Souza). [Additional Reference(s): DWR Levee Log, 2005. USACE Sacramento O&M Manual 112, March 1957, (RM 40.79)].					
FS Date: 8/30/2013

WS view: An abandoned old gate valve on inlet steel pipe on stream bank.

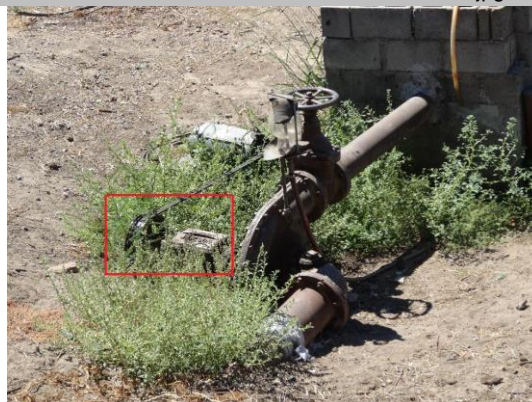
Photo 3 of 3 : UCIP_FA_2018_41646_34100.jpg

LS view: concrete masonry distribution box (top), steel pipe, gate valve, air vent, and pump (left) on levee toe.

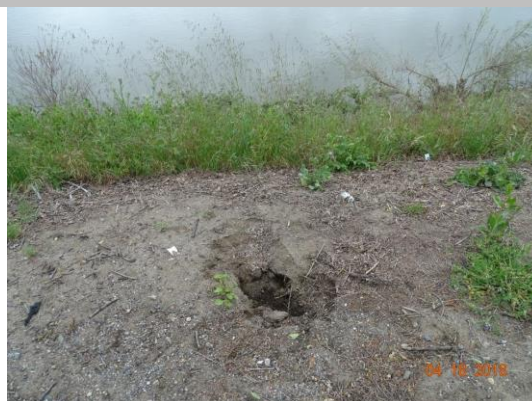
Photo 1 of 1 : FA_2018_RD0150_16_111_20180910_00063.jpg

LM Start	6.73	Rating **	M	Issue No.	111
LM End	6.73	Issue Type +	Ma	Location *	WS
Category	Earthen Levee			GPS Latitude/Longitude	
				Start	End
Item	Animal Control			38.399838 °	38.399838 °
				-121.514898 °	-121.514898 °
DWR ID	DWR_RD0150_02_s_2018_111				
Comment Code					
A3 : No rodents visible, but rodent burrows visible; need to backfill and compact or grout burrows.					
Inspector Comment					
Possible rodent hole or sinkhole forming on waterside shoulder needs to be repaired.

View of possible animal hole on waterside looking east. Spring 2018

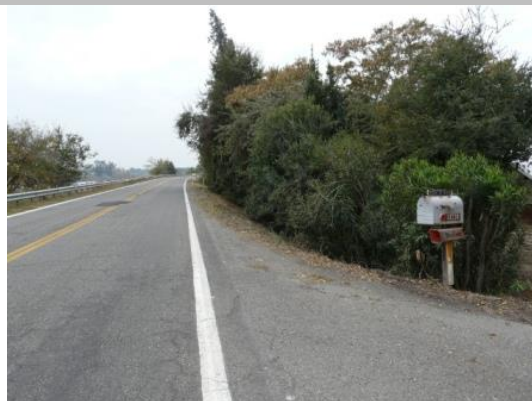
Photo 1 of 1 : FA_2018_RD0150_16_60_20180910_00042.jpg

LM Start	6.76	Rating **	U	Issue No.	60
LM End	6.93	Issue Type +	En	Location *	LS
Category	Earthen Levee			GPS Latitude/Longitude	
				Start	End
Item	Vegetation			38.400284 °	38.402613 °
				-121.515019 °	-121.515863 °
DWR ID	DWR_RD0150_02_s_2012_60				
Comment Code					
V6 : Landscaping					
Inspector Comment

View of dense landscaping providing a screen for a residence on the landside of levee.

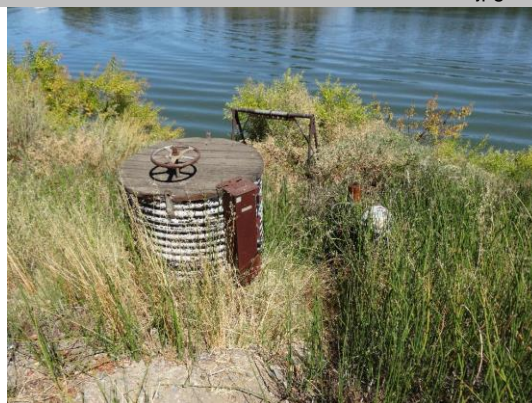
Photo 1 of 3 : UCIP_FA_2018_53333_34162.jpg

Comment Code						
Inspector Comment						
FS_ID:53333 DS_ID:22429 EP_NO: N/A Repair Type: Urgent Crossing Status: Found UCIP Comments: 6/5/2018 Pump in operation at time of inspection. Pipe on WS has significant leak; spilling onto a pile of brush so erosion appears limited, if at all. LS does not appear to have any pipe leaks or levee erosion. Pipe is approximately 85 years and should be internally inspected, and possibly replaced completely, and crossing remains Urgent (DWR UCIP - D. Sanoski). FIELD_STRUCT_DESC: 8-inch concrete encased steel irrigation discharge pipe through the levee, 10 feet below the crown. Pump on a concrete slab and a slide gate in a corrugated metal pipe (CMP) riser on the waterside (WS) slope. Pipe through the levee section is encased in reinforced concrete. Concrete standpipe at the landside (LS) toe. (A. Monice). [Additional Reference(s): DWR Levee Log, 2005. USACE Sacramento O&M Manual 112, March 1957, (RM 41.10), referenced as invert elevation 8.2 feet below the crown]. FS Date: 6/5/2018 1:46:00 PM

WS view: CMP riser with slide gate and pump (right) on levee slope.

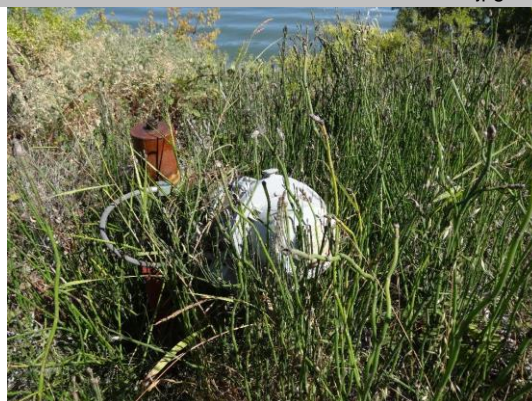
Photo 3 of 3 : UCIP_FA_2018_53333_34160.jpg

Comment Code						
Inspector Comment						
FS_ID:53333 DS_ID:22429 EP_NO: N/A Repair Type: Urgent Crossing Status: Found UCIP Comments: 6/5/2018 Pump in operation at time of inspection. Pipe on WS has significant leak; spilling onto a pile of brush so erosion appears limited, if at all. LS does not appear to have any pipe leaks or levee erosion. Pipe is approximately 85 years and should be internally inspected, and possibly replaced completely, and crossing remains Urgent (DWR UCIP - D. Sanoski). FIELD_STRUCT_DESC: 8-inch concrete encased steel irrigation discharge pipe through the levee, 10 feet below the crown. Pump on a concrete slab and a slide gate in a corrugated metal pipe (CMP) riser on the waterside (WS) slope. Pipe through the levee section is encased in reinforced concrete. Concrete standpipe at the landside (LS) toe. (A. Monice). [Additional Reference(s): DWR Levee Log, 2005. USACE Sacramento O&M Manual 112, March 1957, (RM 41.10), referenced as invert elevation 8.2 feet below the crown]. FS Date: 6/5/2018 1:46:00 PM

WS view: pump on levee slope. Dense vegetation on levee slope.

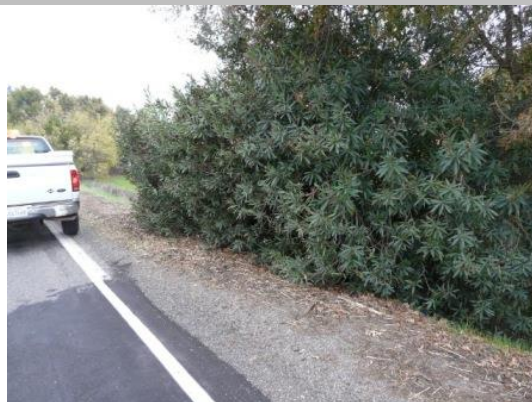
Photo 1 of 1 : FA_2018_RD0150_16_58_20180910_00039.jpg

LM Start	7.01	Rating **	U	Issue No.	58
LM End	7.01	Issue Type +	En	Location *	LS
Category	Earthen Levee			GPS Latitude/Longitude	
				Start	End
Item	Vegetation			38.403631 °	38.403631 °
				-121.516299 °	-121.516299 °
DWR ID	DWR_RD0150_02_s_2012_58				
Comment Code					
V6 : Landscaping					
Inspector Comment

View of dense landscaping on levee slope.

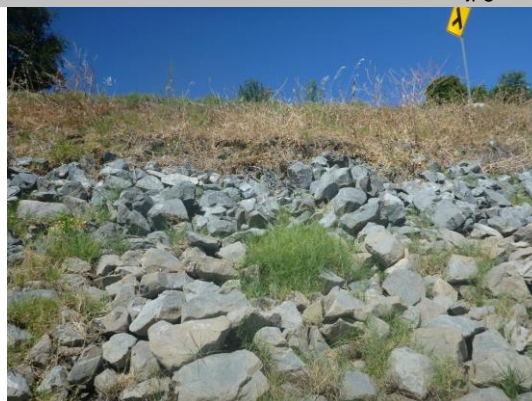
Photo 2 of 4 : LEVAL_FA_2018_289_2163.jpg

Comment Code					
Inspector Comment					
Levee Evaluation Comments					
Description:The flood damage consists of a waterside erosion approximately 311 feet long on the west (right) bank of the Sacramento River. See attached pages for photos.					
Site ID No:289					
Site Designation:LMA-115					
Repair Type: Erosion					
Rating:Area of Concern					
Field Date:7/17/2017					
Notes: Crown is a paved road. 2 scarps 6 ft deep and about 15 ft long each within site and 6 ft from crown, otherwise erosion was pretty small. Rip rap on 3/4 of slope here, but not full coverage. Area of concern because deeper scarps only extended a short distance.

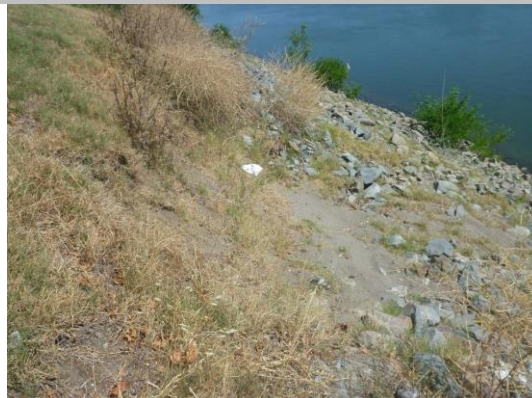
Photo 4 of 4 : LEVAL_FA_2018_289_2168.jpg

Item	2017 Storm Damage			38.405933 °	38.406722 °	
				-121.517197 °	-121.517617 °	
DWR ID	DWR_RD0150_02_f_2017_53					
Comment Code						
Inspector Comment						
Levee Evaluation Comments						
Description:The flood damage consists of a waterside erosion approximately 311 feet long on the west (right) bank of the Sacramento River. See attached pages for photos.						
Site ID No:289						
Site Designation:LMA-115						
Repair Type: Erosion						
Rating:Area of Concern						
Field Date:7/17/2017						
Notes: Crown is a paved road. 2 scarps 6 ft deep and about 15 ft long each within site and 6 ft from crown, otherwise erosion was pretty small. Rip rap on 3/4 of slope here, but not full coverage. Area of concern because deeper scarps only extended a short distance.

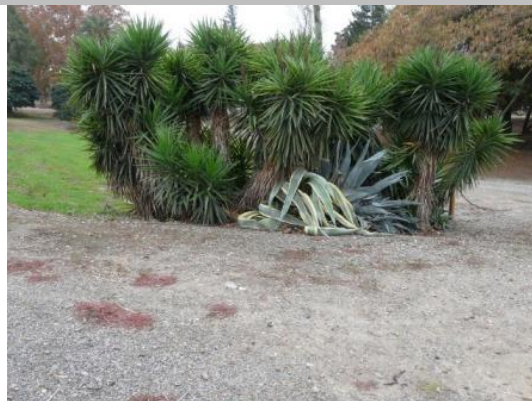
Photo 1 of 1 : FA_2018_RD0150_16_56_20180910_00038.jpg

LM Start	7.79	Rating **	M	Issue No.	56
LM End	7.79	Issue Type +	En	Location *	LS
Category	Earthen Levee		GPS Latitude/Longitude		
			Start	End	
Item	Vegetation		38.413705 °	38.413705 °	
			-121.522806 °	-121.522806 °	
DWR ID	DWR_RD0150_02_s _ 2012_56				
Comment Code					
V6 : Landscaping					
Inspector Comment

Landscaping on landside of levee

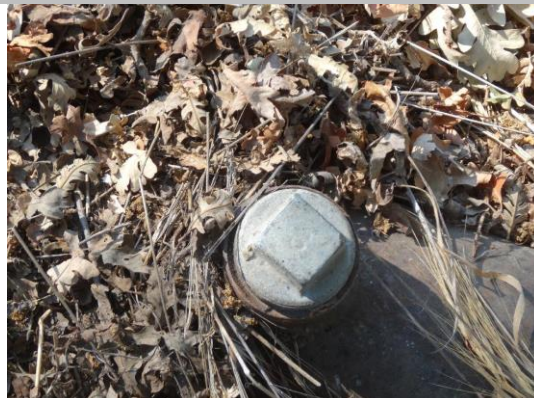
Photo 2 of 3 : UCIP_FA_2018_42694_32004.jpg

LM Start	0.39	Rating **	M	Issue No.	951 (cont)	
LM End	0.39	Issue Type +	En	Location *		
Category	Supplemental			GPS Latitude/Longitude		
				Start	End	
Item	DWR UCIP Field Study			38.337928°	38.337928°	
				-121.581496°	-121.581496°	
DWR ID	22453					
Comment Code						
Inspector Comment						
FS_ID:42694 DS_ID:22453 EP_NO: 13612 Repair Type: Non-Urgent Crossing Status: Found UCIP Comments: Abandoned. Proper abandone needs. FIELD_STRUCT_DESC: *ABANDONED* 6-inch steel gravity irrigation pipe through the levee, 3.5 feet below the crown. Pump and gate valve on the waterside (WS) slope. (Runyon). [Additional Reference(s): DWR Levee Log, 2005]. FS Date: 8/20/2013

WS view: safety valve on steel pipe.

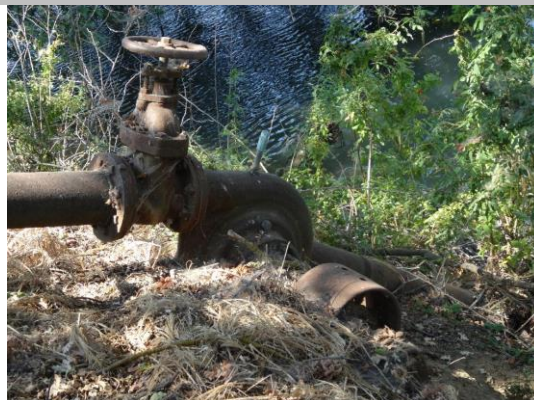
Photo 3 of 3 : UCIP_FA_2018_42694_32003.jpg

WS view: abandoned pipe, gate valve, and pump on levee slope.

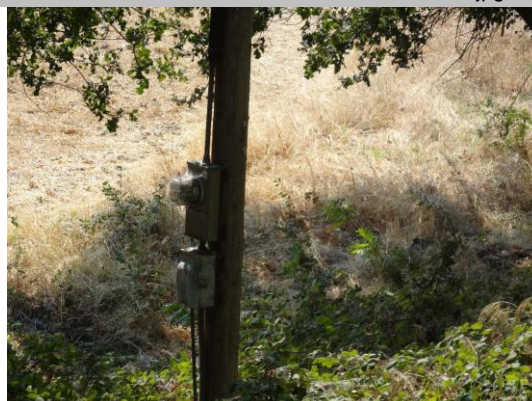
Photo 1 of 3 : UCIP_FA_2018_42693_31979.jpg

LM Start	0.40	Rating **	M	Issue No.	952
LM End	0.40	Issue Type +	En	Location *	
Category	Supplemental			GPS Latitude/Longitude	
				Start	End
Item	DWR UCIP Field Study			38.338131°	38.338131°
				-121.581434°	-121.581434°
DWR ID	22454				
Comment Code					
Inspector Comment					
FS_ID:42693 DS_ID:22454 EP_NO: N/A Repair Type: Non-Urgent Crossing Status: Found UCIP Comments: Seems to be abandoned. Service pole on LS slope. 1" conduit through levee.May need proper abandonment. FIELD_STRUCT_DESC: 6-inch steel irrigation discharge pipe through the levee, 3.5 feet below the crown. Pump and gate valve on the waterside (WS) slope. (Gentner). [Additional Reference(s): DWR Levee Log, 2005]. FS Date: 8/20/2013

LS view: service pole on levee slope.

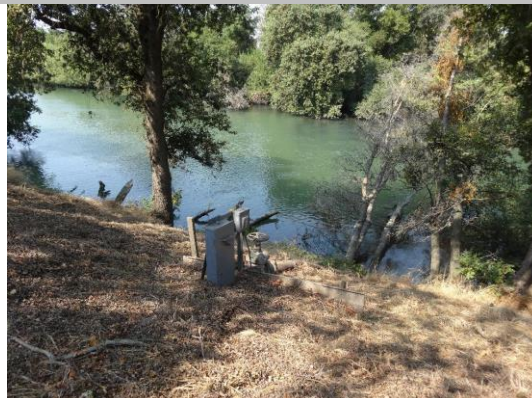
Photo 3 of 3 : UCIP_FA_2018_42693_31977.jpg

LM Start	0.40	Rating **	M	Issue No.	952 (cont)	
LM End	0.40	Issue Type +	En	Location *		
Category	Supplemental			GPS Latitude/Longitude		
				Start	End	
Item	DWR UCIP Field Study			38.338131 °	38.338131 °	
				-121.581434 °	-121.581434 °	
DWR ID	22454					
Comment Code						
Inspector Comment						
FS_ID:42693 DS_ID:22454 EP_NO: N/A Repair Type: Non-Urgent Crossing Status: Found UCIP Comments: Seems to be abandoned. Service pole on LS slope. 1" conduit through levee.May need proper abandonment. FIELD_STRUCT_DESC: 6-inch steel irrigation discharge pipe through the levee, 3.5 feet below the crown. Pump and gate valve on the waterside (WS) slope. (Gentner). [Additional Reference(s): DWR Levee Log, 2005]. FS Date: 8/20/2013

WS view: pipe and pump on levee slope.

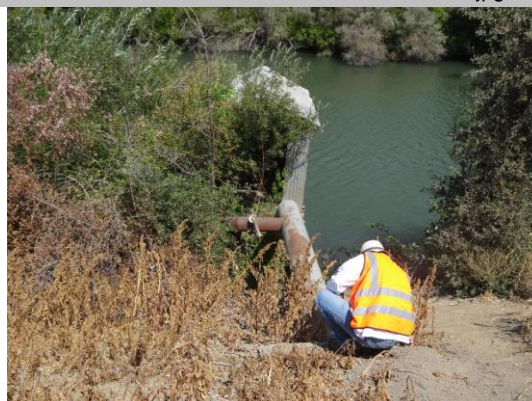
Photo 1 of 3 : UCIP_FA_2018_19112_32044.jpg

LM Start	1.35	Rating **	M	Issue No.	953	
LM End	1.35	Issue Type +	En	Location *		
Category	Supplemental			GPS Latitude/Longitude		
				Start	End	
Item	DWR UCIP Field Study			38.347489 °	38.347489 °	
				-121.573302 °	-121.573302 °	
DWR ID	22433					
Comment Code						
Inspector Comment						
FS_ID:19112 DS_ID:22433 EP_NO: N/A Repair Type: Non-Urgent Crossing Status: Found UCIP Comments: No handrail on wooden walkway. FIELD_STRUCT_DESC: 14-inch steel irrigation discharge pipe through the levee, invert elevation 8 feet below the crown. Pump in a pump house on the waterside (WS) slope. Service pole and steel distribution box on the landside (LS) slope. (A. Pylman). [Additional Reference(s): DWR Levee Log, 2005. USACE Sacramento O&M Manual 112, March 1957, (HLM 1.39)]. FS Date: 8/20/2013

WS view: pipe on levee slope and pump house in channel.

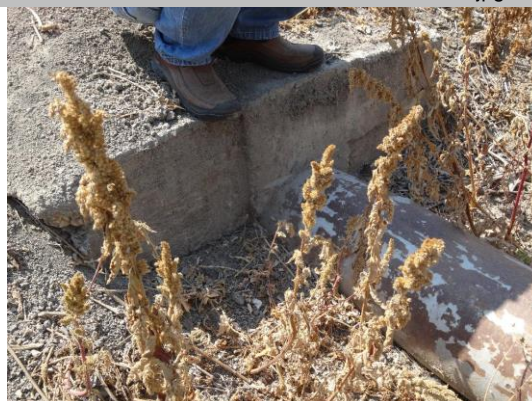
Photo 2 of 3 : UCIP_FA_2018_19112_32043.jpg

LM Start	1.35	Rating **	M	Issue No.	953 (cont)	
LM End	1.35	Issue Type +	En	Location *		
Category	Supplemental			GPS Latitude/Longitude		
				Start	End	
Item	DWR UCIP Field Study			38.347489 °	38.347489 °	
				-121.573302 °	-121.573302 °	
DWR ID	22433					
Comment Code						
Inspector Comment						
FS_ID:19112 DS_ID:22433 EP_NO: N/A Repair Type: Non-Urgent Crossing Status: Found UCIP Comments: No handrail on wooden walkway. FIELD_STRUCT_DESC: 14-inch steel irrigation discharge pipe through the levee, invert elevation 8 feet below the crown. Pump in a pump house on the waterside (WS) slope. Service pole and steel distribution box on the landside (LS) slope. (A. Pylman). [Additional Reference(s): DWR Levee Log, 2005. USACE Sacramento O&M Manual 112, March 1957, (HLM 1.39)]. FS Date: 8/20/2013

WS view: concrete headwall and exposed pipe on levee slope.

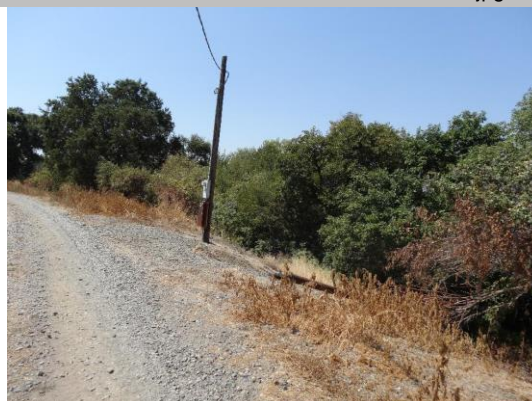
Photo 1 of 3 : UCIP_FA_2018_19137_32108.jpg

WS view: exposed pipe and power pole on levee slope.

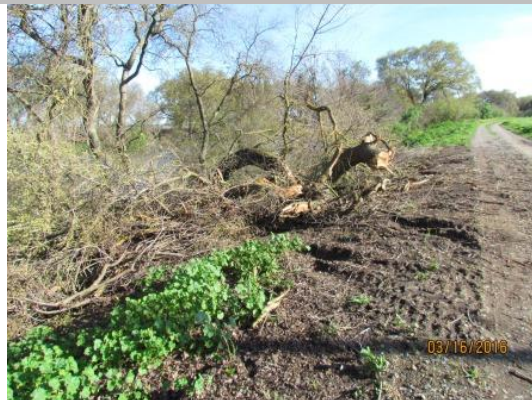
Photo 1 of 1 : FA_2018_RD0150_17_85_20180910_00080.jpg

LM Start	1.83	Rating **	M	Issue No.	85
LM End	1.83	Issue Type +	Ma	Location *	WS
Category	Earthen Levee			GPS Latitude/Longitude	
				Start	End
Item	Encroachments			38.353761 °	38.353761 °
				-121.572390 °	-121.572390 °
DWR ID	DWR_RD0150_03_s_2016_85				
Comment Code					
TR : Tree or limb					
Inspector Comment

View of broken tree trunk on the waterside slope of the levee.

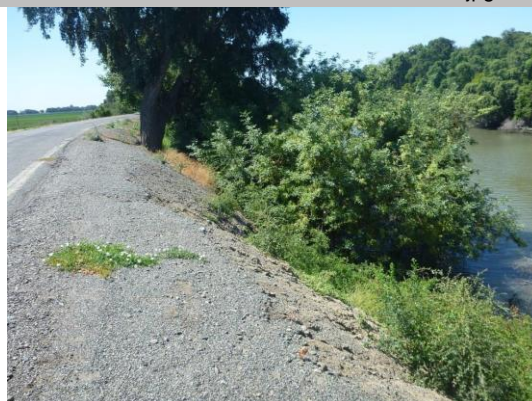
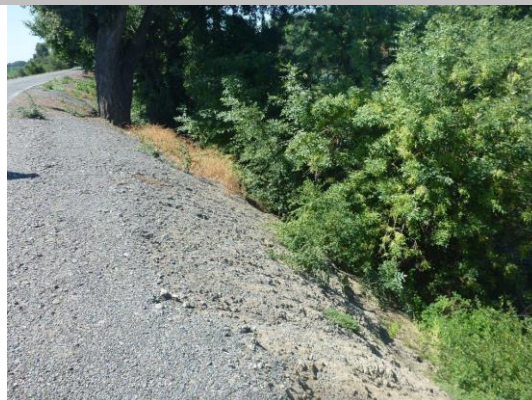
Comment Code					
Inspector Comment					
<p>Levee Evaluation Comments</p> <p>Description: On 11 and 15 January 2017, waterside instability and cracking were observed on the east (left) bank of Elk Slough. The site is approximately 80 feet long and 5 to 10 feet down from the levee crest. See attached pages for photos.</p> <p>Site ID No: 298</p> <p>Site Designation: LMA-124</p> <p>Repair Type: Stability</p> <p>Rating: Area of Concern</p> <p>Field Date: 7/18/2017</p> <p>Notes: No cracking observed, but there is runoff erosion along the entire WS slope here. Crown is a paved road. Area of concern because erosion was caused by runoff and was less severe than other sites along Elk Slough.</p>

Comment Code					
Inspector Comment					
Levee Evaluation Comments					
Description:On 11 and 15 January 2017, waterside instability and cracking were observed on the east (left) bank of Elk Slough. The site is approximately 80 feet long and 5 to 10 feet down from the levee crest. See attached pages for photos.					
Site ID No:298					
Site Designation:LMA-124					
Repair Type: Stability					
Rating:Area of Concern					
Field Date:7/18/2017					
Notes: No cracking observed, but there is runoff erosion along the entire WS slope here. Crown is a paved road. Area of concern because erosion was caused by runoff and was less severe than other sites along Elk Slough.

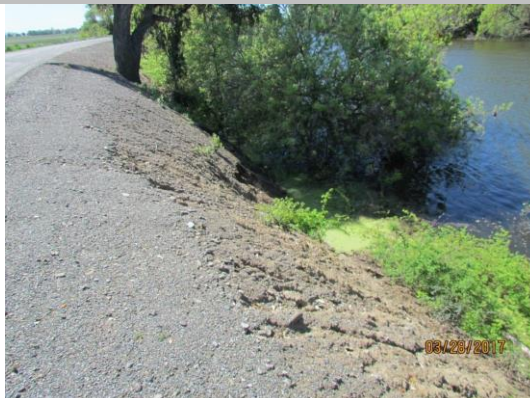
Photo 1 of 1 : FA_2018_RD0150_17_62_20180910_00054.jpg

LM Start	2.75	Rating **	A/W	Issue No.	62
LM End	2.75	Issue Type +	Ma	Location *	WS
Category	Earthen Levee			GPS Latitude/Longitude	
				Start	End
Item	Slope Stability			38.359693°	38.359693°
				-121.561354°	-121.561354°
DWR ID	DWR_RD0150_03_s_2017_62				
Comment Code					
S1 : Repair slope instability.					
Inspector Comment					
Run-off due to rain.

View of slope instability on the waterside slope of the levee looking downstream. Spring 2017

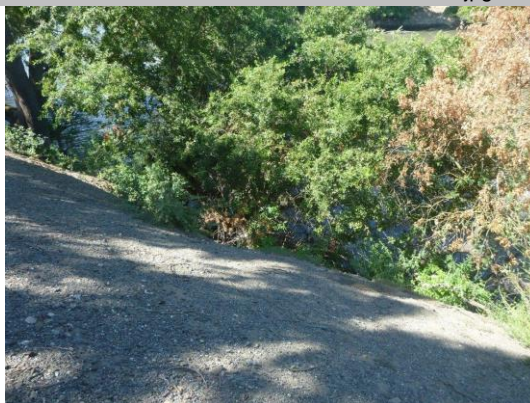
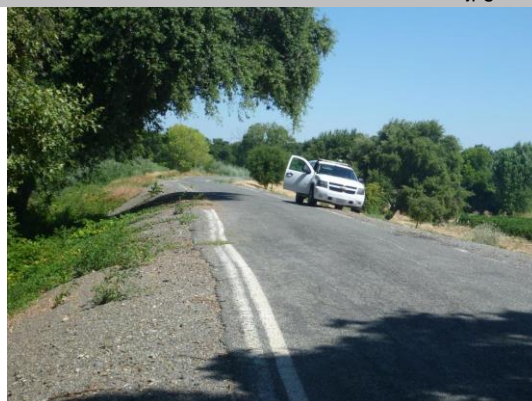
LM Start	2.80	Rating **	A/W	Issue No.	53
LM End	2.81	Issue Type +	Ma	Location *	WS
Category	Supplemental			GPS Latitude/Longitude	
				Start	End
Item	2017 Storm Damage			38.360367 °	38.360544 °
				-121.561592 °	-121.561683 °
DWR ID	DWR_RD0150_03_f _ 2017_53				
Comment Code					
Inspector Comment					
Levee Evaluation Comments					
Description:On 11 January 2017, waterside instability and cracking were observed on the east (left) bank of Elk Slough. The site is approximately 70 feet long and 12 feet down from the levee crest. See attached pages for photos					
Site ID No:299					
Site Designation:LMA-125					
Repair Type: Stability					
Rating:Area of Concern					
Field Date:7/18/2017					
Notes: Crown is a paved road. Cracking on upper 1/3 of slope. Lower 1/2 of slope is near vertical. Area of concern because erosion is less severe than other sites along Elk Slough.

LM Start	2.80	Rating **	A/W	Issue No.	53 (cont)
LM End	2.81	Issue Type +	Ma	Location *	WS
Category	Supplemental			GPS Latitude/Longitude	
				Start	End
Item	2017 Storm Damage			38.360367°	38.360544°
				-121.561592°	-121.561683°
DWR ID	DWR_RD0150_03_f_2017_53				
Comment Code					
Inspector Comment					
Levee Evaluation Comments					
Description:On 11 January 2017, waterside instability and cracking were observed on the east (left) bank of Elk Slough. The site is approximately 70 feet long and 12 feet down from the levee crest. See attached pages for photos					
Site ID No:299					
Site Designation:LMA-125					
Repair Type: Stability					
Rating:Area of Concern					
Field Date:7/18/2017					
Notes: Crown is a paved road. Cracking on upper 1/3 of slope. Lower 1/2 of slope is near vertical. Area of concern because erosion is less severe than other sites along Elk Slough.

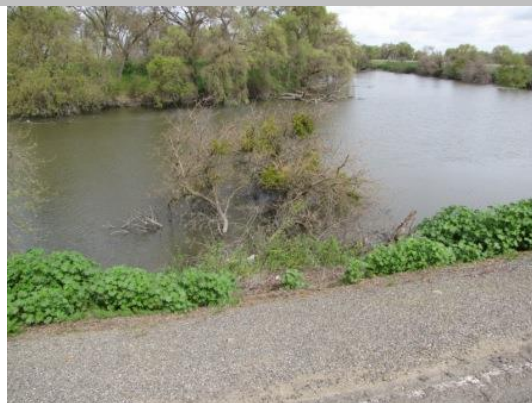
Photo 1 of 1 : FA_2018_RD0150_17_27_20180910_00009.jpg

LM Start	3.34	Rating **	M	Issue No.	27
LM End	3.34	Issue Type +	Ma	Location *	WS
Category	Earthen Levee			GPS Latitude/Longitude	
				Start	End
Item	Encroachments			38.363147 °	38.363147 °
				-121.556190 °	-121.556190 °
DWR ID	DWR_RD0150_03_s_2012_27				
Comment Code					
TR : Tree or limb					
Inspector Comment					
Downed tree on the waterside toe of the levee.

View of downed tree on the waterside slope looking upstream.

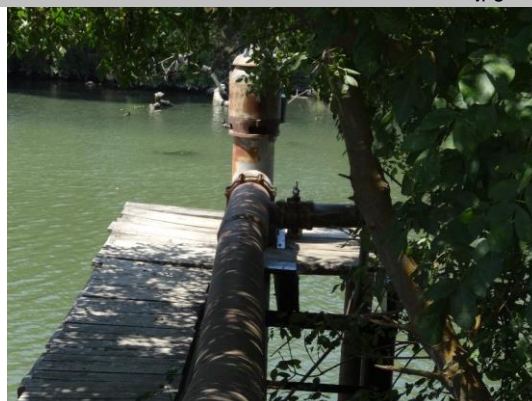
Photo 2 of 3 : UCIP_FA_2018_53334_35012.jpg

Comment Code						
Inspector Comment						
FS_ID:53334 DS_ID:22439 EP_NO: N/A Repair Type: Urgent Crossing Status: Found UCIP Comments: 06/05/2018 Same as last inspection; LS erosion looks the same if not slightly worse, so the crossing remains Urgent (DWR UCIP - D. Sanoski)03/30/2017 Riprap laid around pipe on WS slope. Source of erosion has not been addressed, nor has LS toe been repaired. Update and photo courtesy of Pavel Kazi, FPIIB Inspector, as a part of his Sprint 2017 Inspections. (K. Fazel - UCIP) 11/10/2016 Erosion at LS toe has progressed since last inspection and is now severe. Photo courtesy of Pavel Kazi, FPIIB Inspector, as a part of his Fall 2016 Inspections. Crossing has been upgraded from Non-Urgent to Urgent. (K. Fazel - UCIP)08/20/2013 Leaky concrete standpipe on landside levee toe creating some erosion.- pump was working at the time of inspection. (P. Amatya - DWR) FIELD_STRUCT_DESC: 8-inch steel irrigation discharge pipe through the levee, invert elevation 3.7 feet below the crown. Service pole on the waterside (WS) slope. Pump on a piling structure in the stream. Concrete standpipe at the landside (LS) toe. [Additional Reference(s): DWR Levee Log, 2005. USACE Sacramento O&M Manual 112, March 1957, (RM 3.45)]. FS Date: 6/5/2018 3:29:00 PM

WS view: steel pipe & pump, walkway, pump support in the channel.

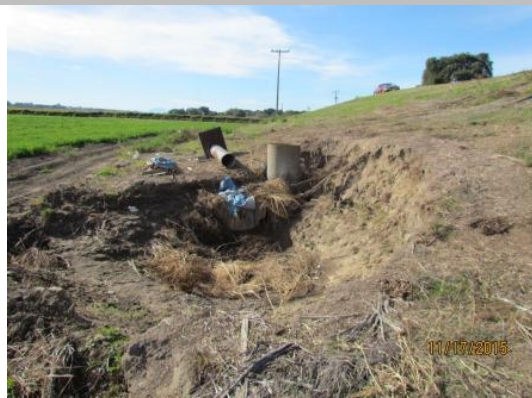
Photo 2 of 3 : FA_2018_RD0150_17_115_20180910_00112.jpg

View of the ditch on the landside toe of the levee during fall 2015 inspection.

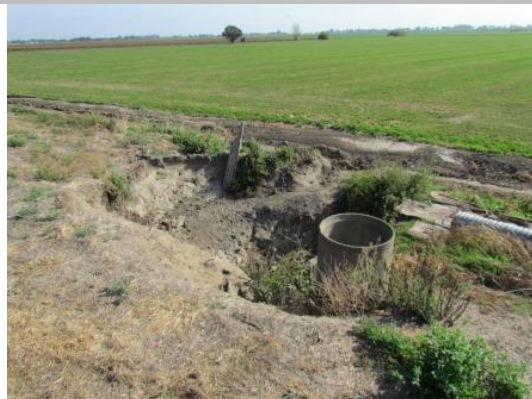
Photo 3 of 3 : FA_2018_RD0150_17_115_20180910_00113.jpg

A drainage ditch with depth of 4 feet and width of 15 feet was found on the landside toe of the levee. The picture was taken from the landside slope looking upstream during the fall 2013 inspection.

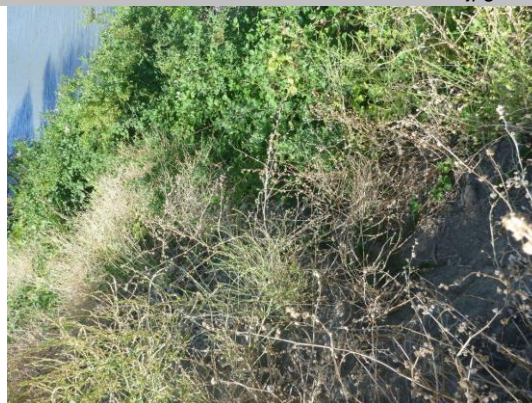
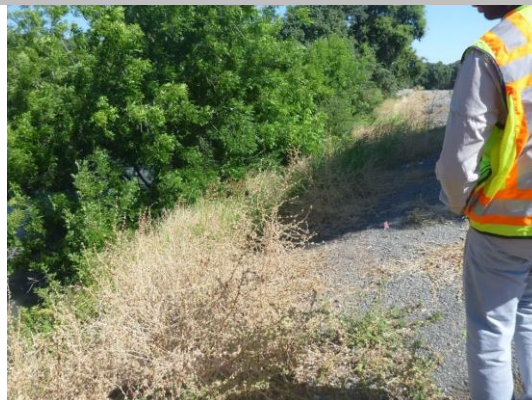
Comment Code					
Inspector Comment					
Levee Evaluation Comments					
Description:On 11 January 2017 and 7 February 2017, waterside instability and erosion were observed on the east (left) bank of Elk Slough. The site is approximately 43 feet long and 11 feet down from the levee crest. See attached pages for photos.					
Site ID No:302					
Site Designation:LMA-128					
Repair Type: Erosion					
Rating:Area of Concern					
Field Date:7/18/2017					
Notes: Erosion on lower 2/3 of slope. Crown is a paved road. Area of concern because erosion was not as severe and there was lots of vegetation on the lower slope indicating damage may be older. WS slope has been rocked just downstream of this site.

Item	2017 Storm Damage			38.364450 °		38.364567 °
				-121.555331 °		-121.555333 °
DWR ID	DWR_RD0150_03_f_2017_91					
Comment Code						
Inspector Comment						
Levee Evaluation Comments						
Description:On 11 January 2017 and 7 February 2017, waterside instability and erosion were observed on the east (left) bank of Elk Slough. The site is approximately 43 feet long and 11 feet down from the levee crest. See attached pages for photos.						
Site ID No:302						
Site Designation:LMA-128						
Repair Type: Erosion						
Rating:Area of Concern						
Field Date:7/18/2017						
Notes: Erosion on lower 2/3 of slope. Crown is a paved road. Area of concern because erosion was not as severe and there was lots of vegetation on the lower slope indicating damage may be older. WS slope has been rocked just downstream of this site.

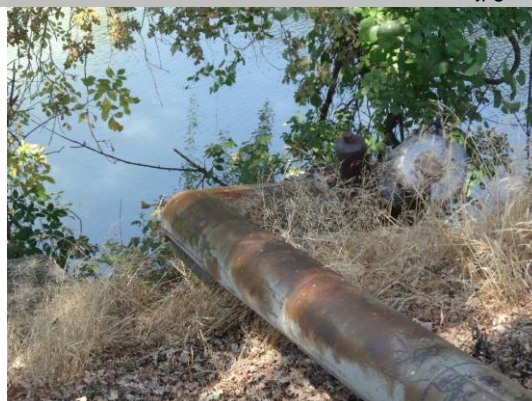
Photo 1 of 3 : UCIP_FA_2018_50202_35018.jpg

Comment Code					
Inspector Comment					
FS_ID:50202 DS_ID:22440 EP_NO: N/A Repair Type: Non-Urgent Crossing Status: Found UCIP Comments: 07/07/2016: Unable to locate evidence of major depression of WS slope. Only slight depression on WS slope above pump. Though this is an up-and-over pipe, no positive closure device found. Inlet in LS standpipe is capped with a board. If no longer in use, needs to be abandoned properly. Siphon breaker/vent on WS needs a cover. Wave-wash run-up along river bank characteristic of much of Elk Slough. Crossing has been downgraded from Urgent to Non-Urgent. (K. Fazel - UCIP)08/20/2013:Levee damage.Gate valve on WS not found. (P. Amatya - DWR) FIELD_STRUCT_DESC: 12-inch steel irrigation discharge pipe through the levee, invert elevation 5.9 feet below the crown. Slant pump on the waterside (WS) slope. Vent/siphon breaker at the apex of the pipe on the WS. Concrete platform lies next to the pump on the WS. Concrete standpipe and service pole with meter at the landside (LS) toe. Property owner is Ken Pylman at (916) 775-1066. [Additional Reference(s): DWR Levee Log, 2005. USACE Sacramento O&M Manual 112, March 1957, (HLM 3.73)]. FS Date: 7/7/2016

WS view: steel pipe and pump on levee slope.

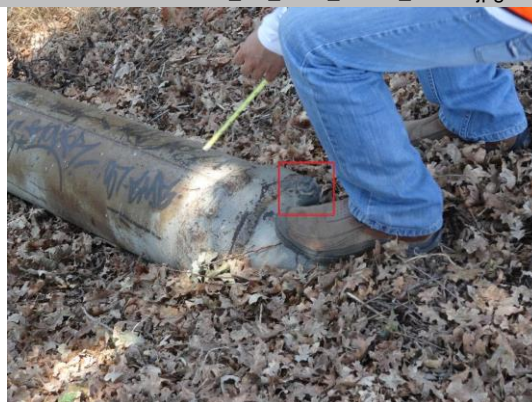
Photo 2 of 3 : UCIP_FA_2018_50202_35021.jpg

WS view: steel pipe with safety valve (marked) on levee slope.

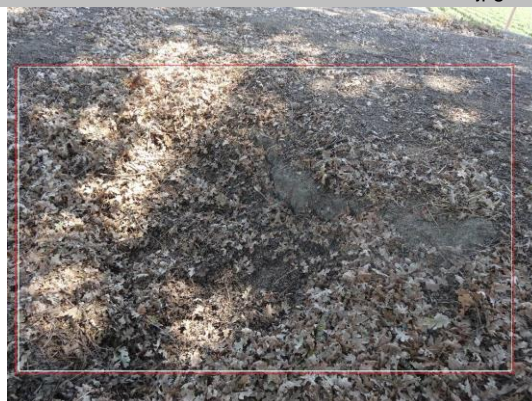
Photo 3 of 3 : UCIP_FA_2018_50202_35017.jpg

Comment Code						
Inspector Comment						
FS_ID:50202						
DS_ID:22440						
EP_NO: N/A						
Repair Type: Non-Urgent						
Crossing Status: Found						
UCIP Comments: 07/07/2016: Unable to locate evidence of major depression of WS slope. Only slight depression on WS slope above pump. Though this is an up-and-over pipe, no positive closure device found. Inlet in LS standpipe is capped with a board. If no longer in use, needs to be abandoned properly. Siphon breaker/vent on WS needs a cover. Wave-wash run-up along river bank characteristic of much of Elk Slough. Crossing has been downgraded from Urgent to Non-Urgent. (K. Fazel - UCIP)08/20/2013:Levee damage.Gate valve on WS not found. (P. Amatya - DWR)						
FIELD_STRUCT_DESC: 12-inch steel irrigation discharge pipe through the levee, invert elevation 5.9 feet below the crown. Slant pump on the waterside (WS) slope. Vent/siphon breaker at the apex of the pipe on the WS. Concrete platform lies next to the pump on the WS. Concrete standpipe and service pole with meter at the landside (LS) toe. Property owner is Ken Pylman at (916) 775-1066. [Additional Reference(s): DWR Levee Log, 2005. USACE Sacramento O&M Manual 112, March 1957, (HLM 3.73)].

WS view: soil erosion (depression) on levee slope.

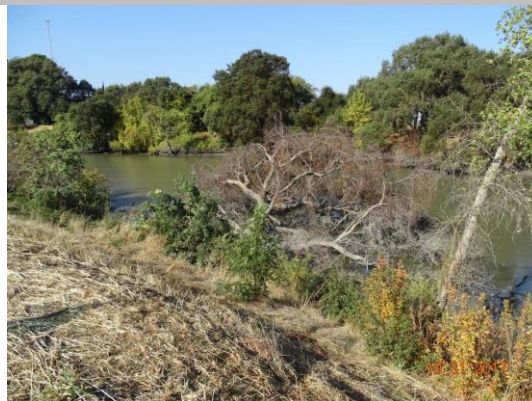
Photo 1 of 1 : FA_2018_RD0150_17_126_20180910_00130.jpg

View of a fallen tree on the waterside toe of the levee. Fall 2017

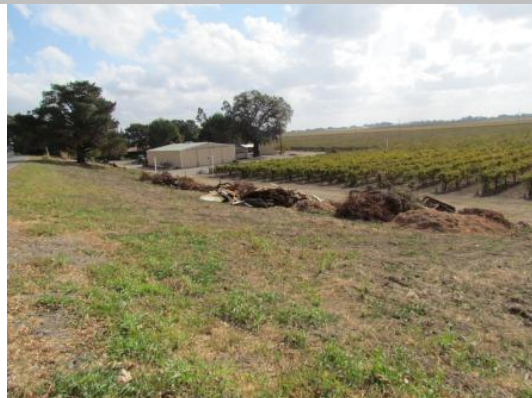
Photo 1 of 1 : FA_2018_RD0150_17_51_20180910_00040.jpg

LM Start	4.38	Rating **	M	Issue No.	51
LM End	4.38	Issue Type +	En	Location *	LS
Category	Earthen Levee			GPS Latitude/Longitude	
				Start	End
Item	Encroachments			38.374269 °	38.374269 °
				-121.549385 °	-121.549385 °
DWR ID	DWR_RD0150_03_s_2012_51				
Comment Code					
DE : Debris					
Inspector Comment

View of the pruning pile on the landside of the levee looking upstream during the fall 2013 inspection.

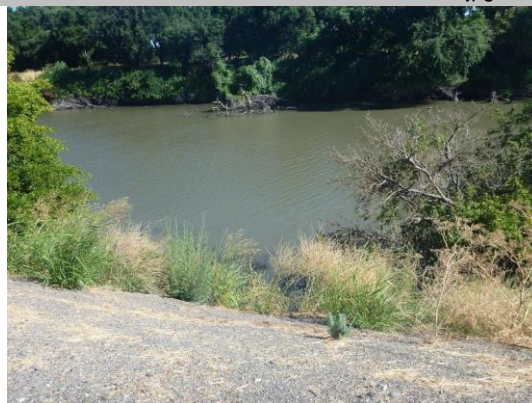
Photo 1 of 3 : LEVAL_FA_2018_304_2072.jpg

Comment Code						
Inspector Comment						
Levee Evaluation Comments						
Description:Between 11 and 19 January 2017, waterside instability and erosion were observed on the east (left) bank of Elk Slough. The site is approximately 88 feet long, 7 feet below the levee crest, and includes a fallen tree and exposed root ball in the levee slope. See attached pages for photos.						
Site ID No:304						
Site Designation:LMA-130						
Repair Type: Erosion						
Rating:Serious						
Field Date:7/18/2017						
Notes: Crown is a paved road. Near vertical on lower 1/2 of slope oncluding a fallen tree with exposed root ball. Serious because sloughing cuts into already oversteepened prism significantly and visible longitudinal cracking near crown.

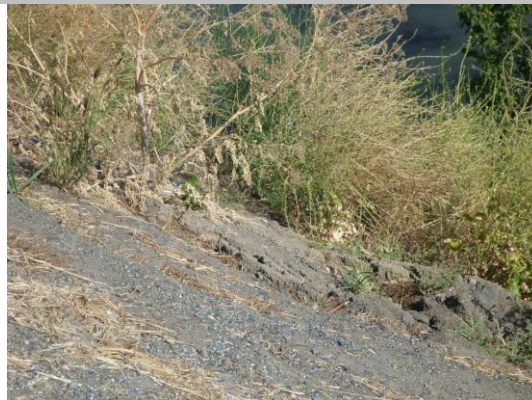
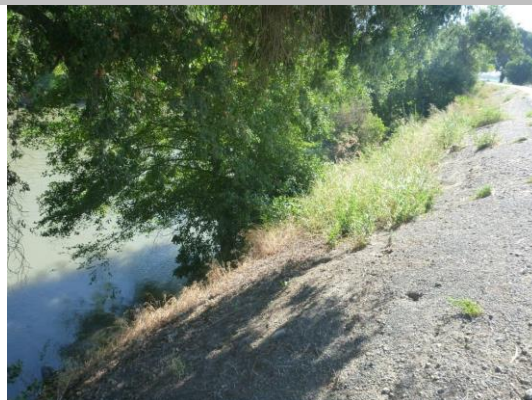
Description: Between 11 and 19 January 2017, waterside instability and erosion were observed on the east (left) bank of Elk Slough. The site is approximately 88 feet long, 7 feet below the levee crest, and includes a fallen tree and exposed root ball in the levee slope. See attached pages for photos.

Notes: Crown is a paved road. Near vertical on lower 1/2 of slope oncluding a fallen tree with exposed root ball. Serious because sloughing cuts into already oversteepened prism significantly and visible longitudinal cracking near crown.

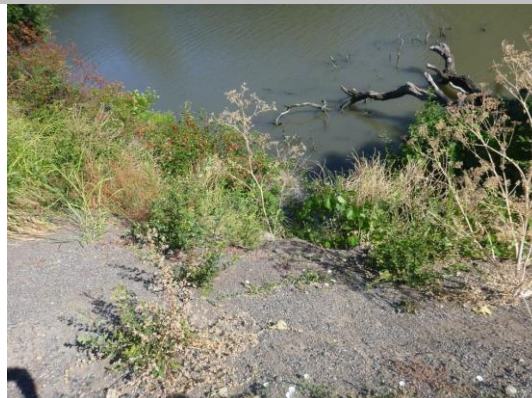
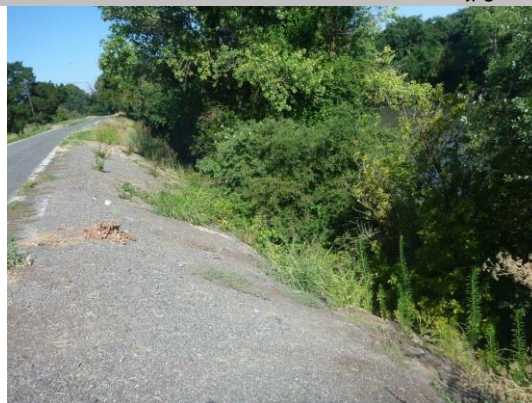
Comment Code					
Inspector Comment					
Levee Evaluation Comments					
Description:Between 11 January 2017 and 7 February 2017, instability, cracking, and erosion of the waterside levee slope were observed on the east (left) bank of Elk Slough. The site is approximately 88 feet long. See attached pages for photos.					
Site ID No:305					
Site Designation:LMA-131					
Repair Type: Erosion					
Rating:Serious					
Field Date:7/18/2017					
Notes: Crown is a paved road. Near vertical sloughing on the lower 2/3 of the prism. House and ramp/driveway on the LS. Serious because sloughing cuts into already oversteepened prism significantly.

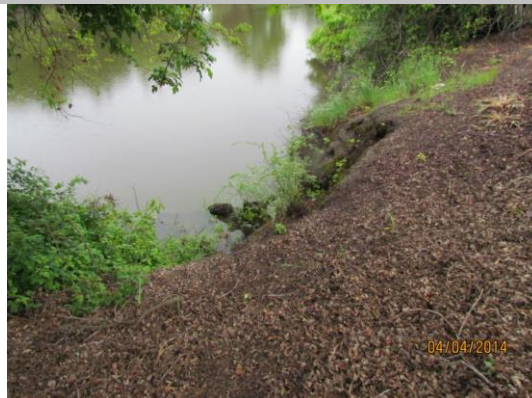
Photo 1 of 1 : FA_2018_RD0150_17_80_20180910_00075.jpg

LM Start	4.49	Rating **	A/W	Issue No.	80
LM End	4.49	Issue Type +	Ob	Location *	WS
Category	Earthen Levee			GPS Latitude/Longitude	
				Start	End
Item	Erosion / Bank Caving			38.374355°	38.374355°
				-121.547436°	-121.547436°
DWR ID	DWR_RD0150_03_s_2014_80				
Comment Code					
E2 : Schedule repair of erosion site prior to the next inspection.					
Inspector Comment

View of an erosion site on the waterside toe of the levee looking upstream. Spring 2014

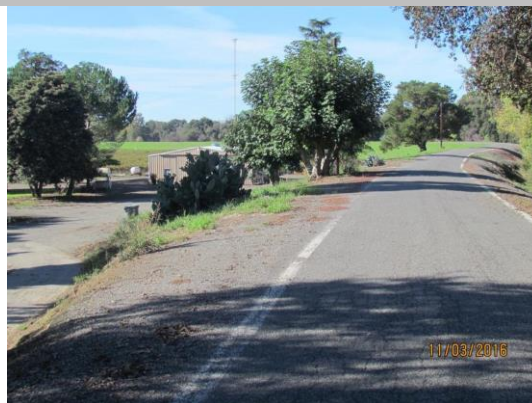
Photo 1 of 1 : FA_2018_RD0150_17_94_20180910_00091.jpg

LM Start	4.49	Rating **	M	Issue No.	94
LM End	4.49	Issue Type +	En	Location *	LS
Category	Earthen Levee			GPS Latitude/Longitude	
				Start	End
Item	Vegetation			38.374367 °	38.374367 °
				-121.547327 °	-121.547327 °
DWR ID	DWR_RD0150_03_s_2012_94				
Comment Code					
V6 : Landscaping					
Inspector Comment

View of landscape on the landside shoulder of the levee. Fall 2016

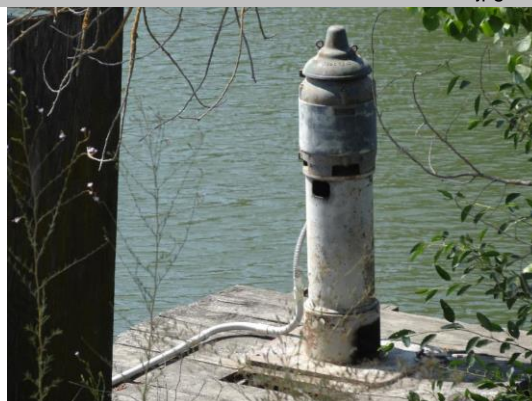
Photo 1 of 3 : UCIP_FA_2018_19281_32541.jpg

LM Start	4.63	Rating **	M	Issue No.	957
LM End	4.63	Issue Type +	En	Location *	
Category	Supplemental			GPS Latitude/Longitude	
				Start	End
Item	DWR UCIP Field Study			38.374934 °	38.374934 °
				-121.545029 °	-121.545029 °
DWR ID	22444				
Comment Code					
Inspector Comment					
FS_ID:19281 DS_ID:22444 EP_NO: N/A Repair Type: Non-Urgent Crossing Status: Found UCIP Comments: - service pole on LS. 1" conduit on WS.- levee toe cut out on landside.- walkway and gate. FIELD_STRUCT_DESC: 10-inch steel irrigation discharge pipe through the levee, invert elevation 3.8 feet below the crown. Pump on pilings in the stream. Concrete standpipe at the landside (LS) toe. (P. Cook). [Additional Reference(s): DWR Levee Log, 2005. USACE Sacramento O&M Manual 112, March 1957, (HLM 4.71)]. FS Date: 8/20/2013

WS view: vertical pump on deck.

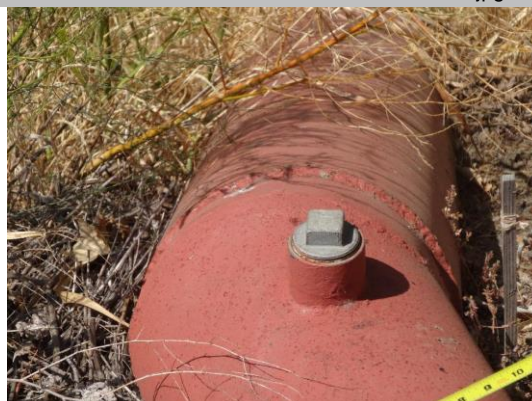
Photo 3 of 3 : UCIP_FA_2018_19281_32539.jpg

WS view: safety valve on steel pipe.

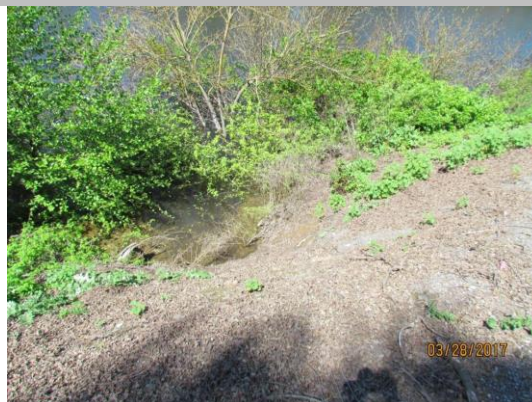
Photo 1 of 1 : FA_2018_RD0150_17_101_20180910_00098.jpg

LM Start	4.79	Rating **	M	Issue No.	101
LM End	4.79	Issue Type +	Ma	Location *	WS
Category	Earthen Levee			GPS Latitude/Longitude	
				Start	End
Item	Erosion / Bank Caving			38.376562 °	38.376562 °
				-121.543016 °	-121.543016 °
DWR ID	DWR_RD0150_03_s_2017_101				
Comment Code					
E2 : Schedule repair of erosion site prior to the next inspection.					
Inspector Comment

View of an erosion on the waterside toe of the levee. Spring 2017

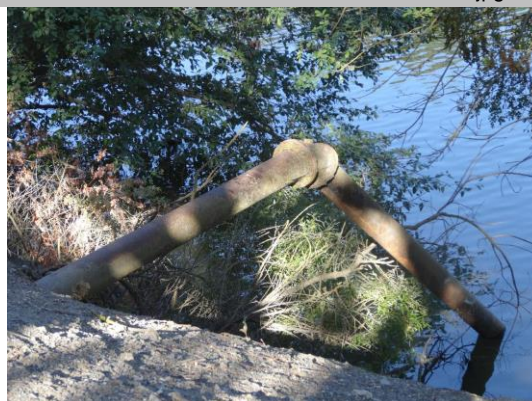
Photo 1 of 3 : UCIP_FA_2018_19283_32565.jpg

LM Start	4.90	Rating **	M	Issue No.	958
LM End	4.90	Issue Type +	En	Location *	
Category	Supplemental			GPS Latitude/Longitude	
				Start	End
Item	DWR UCIP Field Study			38.377718 °	38.377718 °
				-121.541413 °	-121.541413 °
DWR ID	22445				
Comment Code					
Inspector Comment					
FS_ID:19283 DS_ID:22445 EP_NO: N/A Repair Type: Non-Urgent Crossing Status: Found UCIP Comments: - seems abandoned.- may need proper abandonment FIELD_STRUCT_DESC: *ABANDONED* 10-inch steel irrigation discharge pipe through the levee, invert elevation 7.2 feet below the crown. Gate valve on the landside (LS) end. (D. Conner). [Additional Reference(s): DWR Levee Log, 2005. USACE Sacramento O&M Manual 112, March 1957, (HLM 4.99)]. FS Date: 8/23/2013

WS view: steel pipe on levee slope and in the stream.

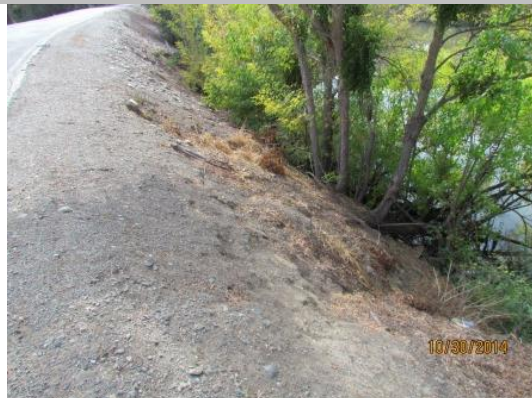
Photo 1 of 1 : FA_2018_RD0150_17_81_20180910_00076.jpg

LM Start	5.05	Rating **	M	Issue No.	81
LM End	5.05	Issue Type +	Ob	Location *	WS
Category	Earthen Levee			GPS Latitude/Longitude	
				Start	End
Item	Erosion / Bank Caving			38.379608 °	38.379608 °
				-121.540082 °	-121.540082 °
DWR ID	DWR_RD0150_03_f_2014_81				
Comment Code					
E2 : Schedule repair of erosion site prior to the next inspection.					
Inspector Comment

View of erosion on the waterside of the levee looking downstream. Fall 2014
